Electrostatic Discharge on a Compressor Train

John Winterton

Principal Engineer
Bently Nevada Corporation
e-mail: john.winterton@bently.com

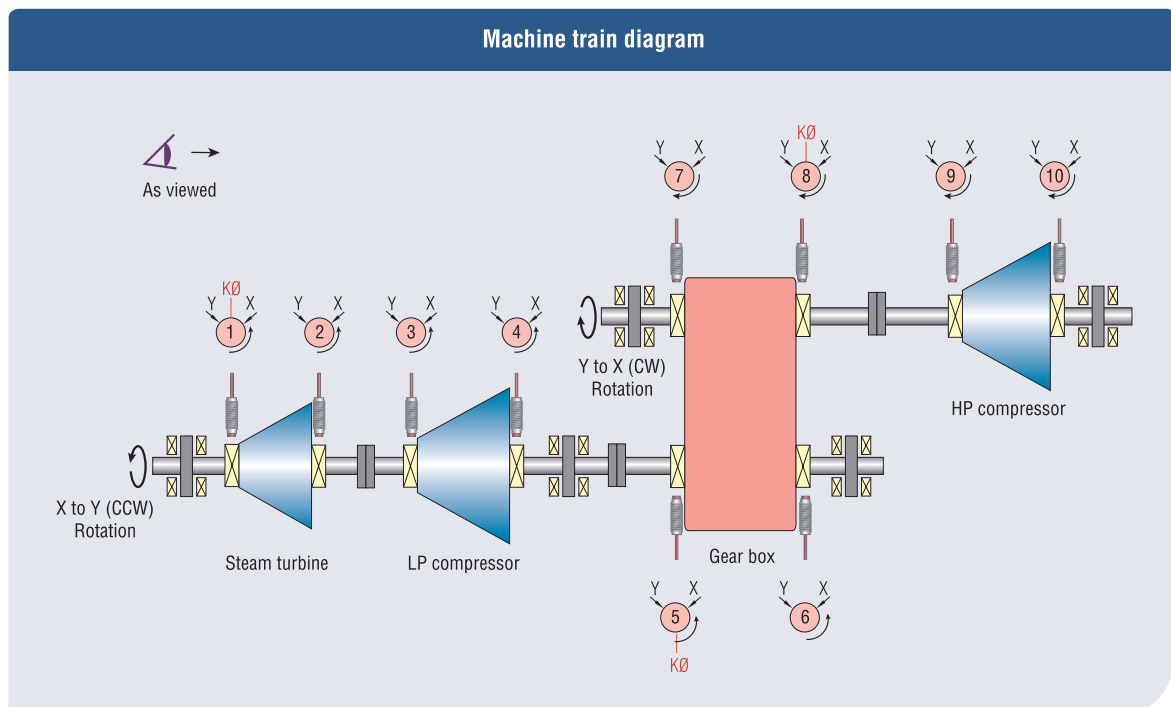
Figure 1.

Data from a Dynamic Data Manager® system at a chemical plant in a Pacific Rim country was recently transmitted to Bently Nevada's machinery diagnostic services personnel. The customer was seeking advice regarding unusual observations with a machine train. Summarized in Figure 1, the train consists of a steam turbine as a prime mover (8750 rpm), driving a low-pressure (LP) compressor with double shaft extensions. The LP compressor was coupled to a speed-increasing gearbox to drive a high-pressure (HP) compressor (13,307 rpm). All the elements of the machine train were equipped with XY proximity probes, including the gearbox shaft extensions. Low-speed shaft bearing clearances on the gearbox are 229 μm (9 mils) nominal and the high-speed bearings are 203 μm

(8 mils) nominal. Gearbox arrangement is “downmesh”; i.e., the pinion is driven down and the gear wants to move upward.
